VICTORIA GARDENS, OLD STEINE, BRIGHTON

ASSESSMENT OF SHALLOW SUBSURFACE GEOLOGICAL ANOMALIES

13 MAY 2022

Ref: 15707/03/HOP/RPT/01A

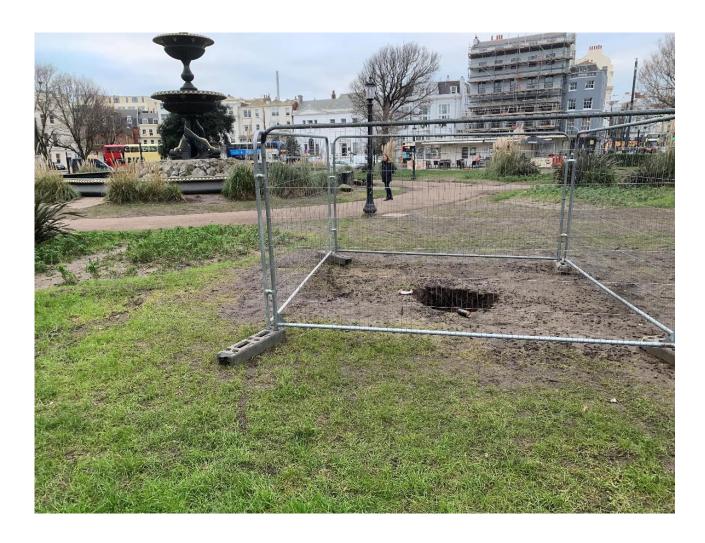
- 1.1 Instructions were received from Brighton & Hove City Council to review the occurrence of a shallow surface void in a grassed area of Victoria Gardens, The Old Steine, Brighton.
- 1.2 The purpose of this report was to consider the likely cause of this void and consequently what risks there might be of similar voids occurring.
- 1.3 It is understood the void was revealed following the removal of a Christmas Market in late 2021, where some large amusement rides were installed (see Photographs 1 and 2 in Appendix A). On removal of these rides, some depressions were found looking like the rides' heavy baseplates had borne down on the ground and a void had appeared (see Photographs 2 and 3).
- 1.4 This void appeared in the northeast part of the garden (see Photograph 1 in Appendix A and Site Plan SK7 in Appendix B).

Photograph 1: Victoria Fountain looking southwest, swallow hole in foreground

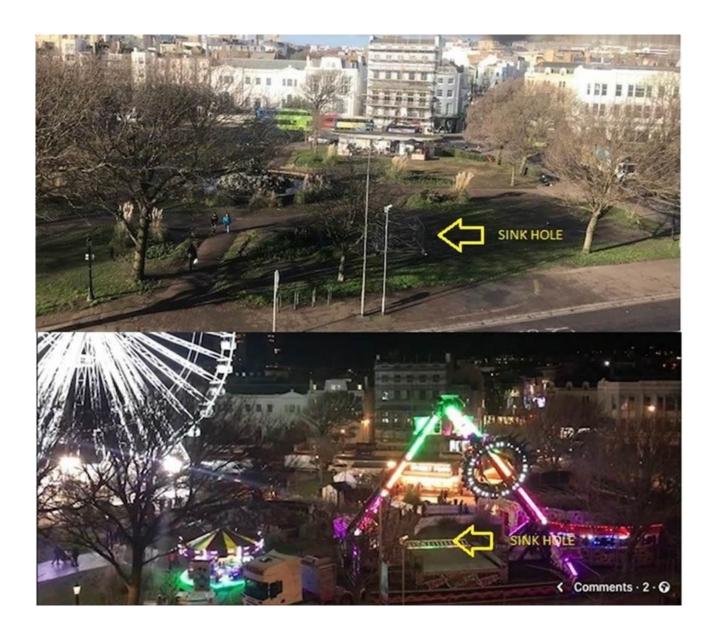
- 2.1 It is understood that around November 2021 a large amusement ride was placed in the vicinity of the subsequent cavity.
 - We were sent Photographs 2 and 3 (see Appendix A), showing this amusement ride in place.

- 2.2 On removal of the ride, a cavity appeared almost directly beneath where one of the large 'feet' of the amusement ride had been placed.
- 2.3 HOP attended site in January 2021 and took a confirming photograph. (See Appendix A Photograph 4, shows a void and Photograph 5, a very similar shaped depression close by). The ground was probed with 6mm steel probes and the void and very loose material was assessed at being about 2m deep on the subsequent visit (see Sketch 15707-3-SK7 in Appendix B).

Photographs 2 & 3: (Credit unknown – received from Brighton & Hove City Council 24 January 2022). Understood to show large amusement ride in position (bottom photo) and situation without ride in place taken from a similar location. November 2021 or January 2022?

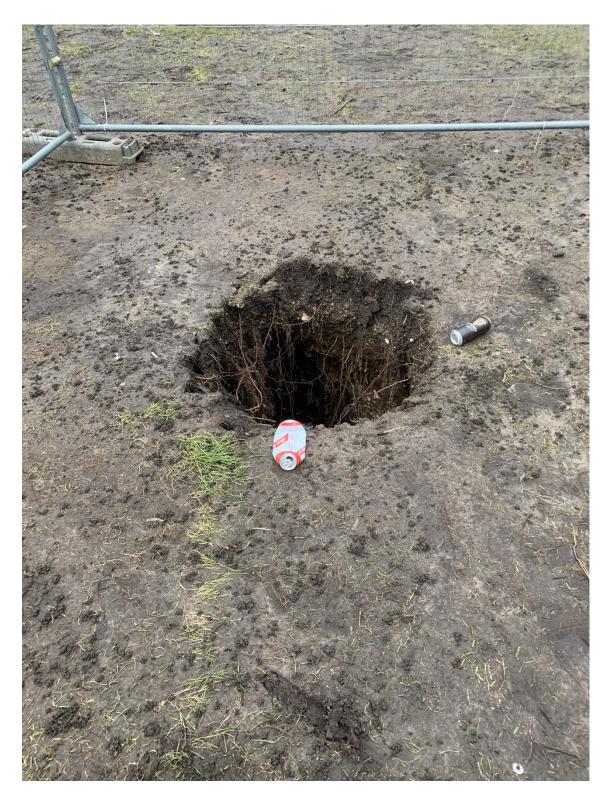
- 4.2 The Victoria Gardens swallow hole appears to have occurred by surface and subterranean water flow dissolving finer material and carrying this away in solution, forming a cavity.

- 5.1 From our surface visible observations, it would appear that a high load from a jack has 'punched through' surface layers in an area where a void probably already existed below, as the load imposed by that jack, locally, was far greater than any general use would have generated before.

Photograph 4: Close up of swallow hole 31 January 2022. (Note almost 'square' shape).

- 5.2 Provided any exceptional future points loads, such as heavy lorry wheels or stabilising jacks are appropriately dealt with by means of suitably sized spreaders and the situation properly monitored, then we do not believe there is cause for immediate concern in respect of additional swallow holes appearing.

- 5.3 However, it should be confirmed that the nearby large diameter surface water sewers are in good condition; that they are free from leaks and that there is no material leaching into them from the filled ground around.

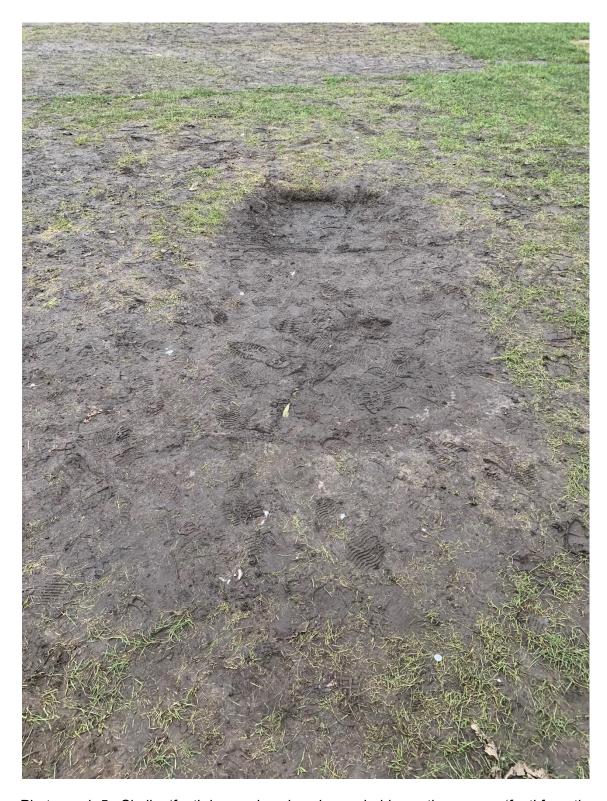
Photograph 5: Similar 'foot' depression close by, probably another square 'foot' from the amusement ride.

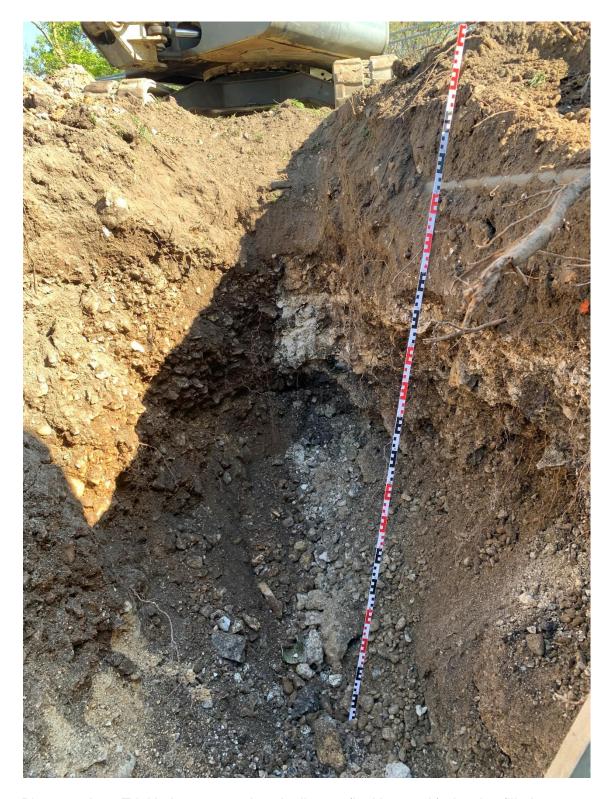
- 2.7 The trail pit excavated all the loose material around the void forming a trench about 4.7m long, 1.5m wide and 2.1m deep see Photograph 6.
- 2.8 The trial pit was subsequently backfilled, compacted and made good.
- 2.9 As a separate exercise, HOP have, in conjunction with Brighton & Hove City Council Officers, been assessing the nearby Victoria Gardens 'Dolphin Statue' Fountain. However, the issue here is with the superstructure of the statue (corroding bolts and services above ground). These are not related to the site geology or nearby void.

- 4.3 This may be related to the large brick sewer running down the east side of Victoria Gardens; during the trial pit excavations evidence of chalk filling was found, which could be from the original construction of the sewer.

Photograph 6: Trial hole excavated 27 April 2022 (looking north) showing filled nature of ground and chalk filling on the side of the nearby sewer.

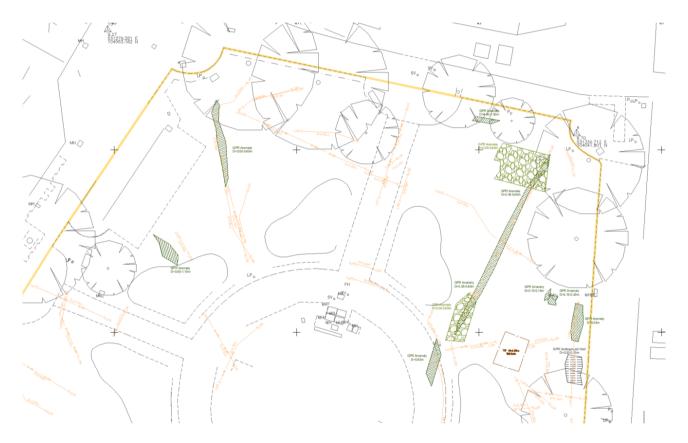
Figure 3 - Exported Wide Range data

Figure 3 shows the results exported into AutoCAD. The Wide Range results are the beige, green and grey polylines and the base plan has been put into grayscale to make the results easier to visualise.

The coloured polylines/hatches take the form of reflectors, which are classed as linear features (beige), anomalies (green) and voids (grey) within the radar data set. The beige shown on the section surveyed is representing geological signatures related to unknown linear features (possible utilities).
