**NEW ENGLAND HOUSE
SHORT TERM MITIGATION REPORT**

New England House

Document Number: BHCNEH-FIR-XX-00-RP-X-0002
Document Revision: [P03]

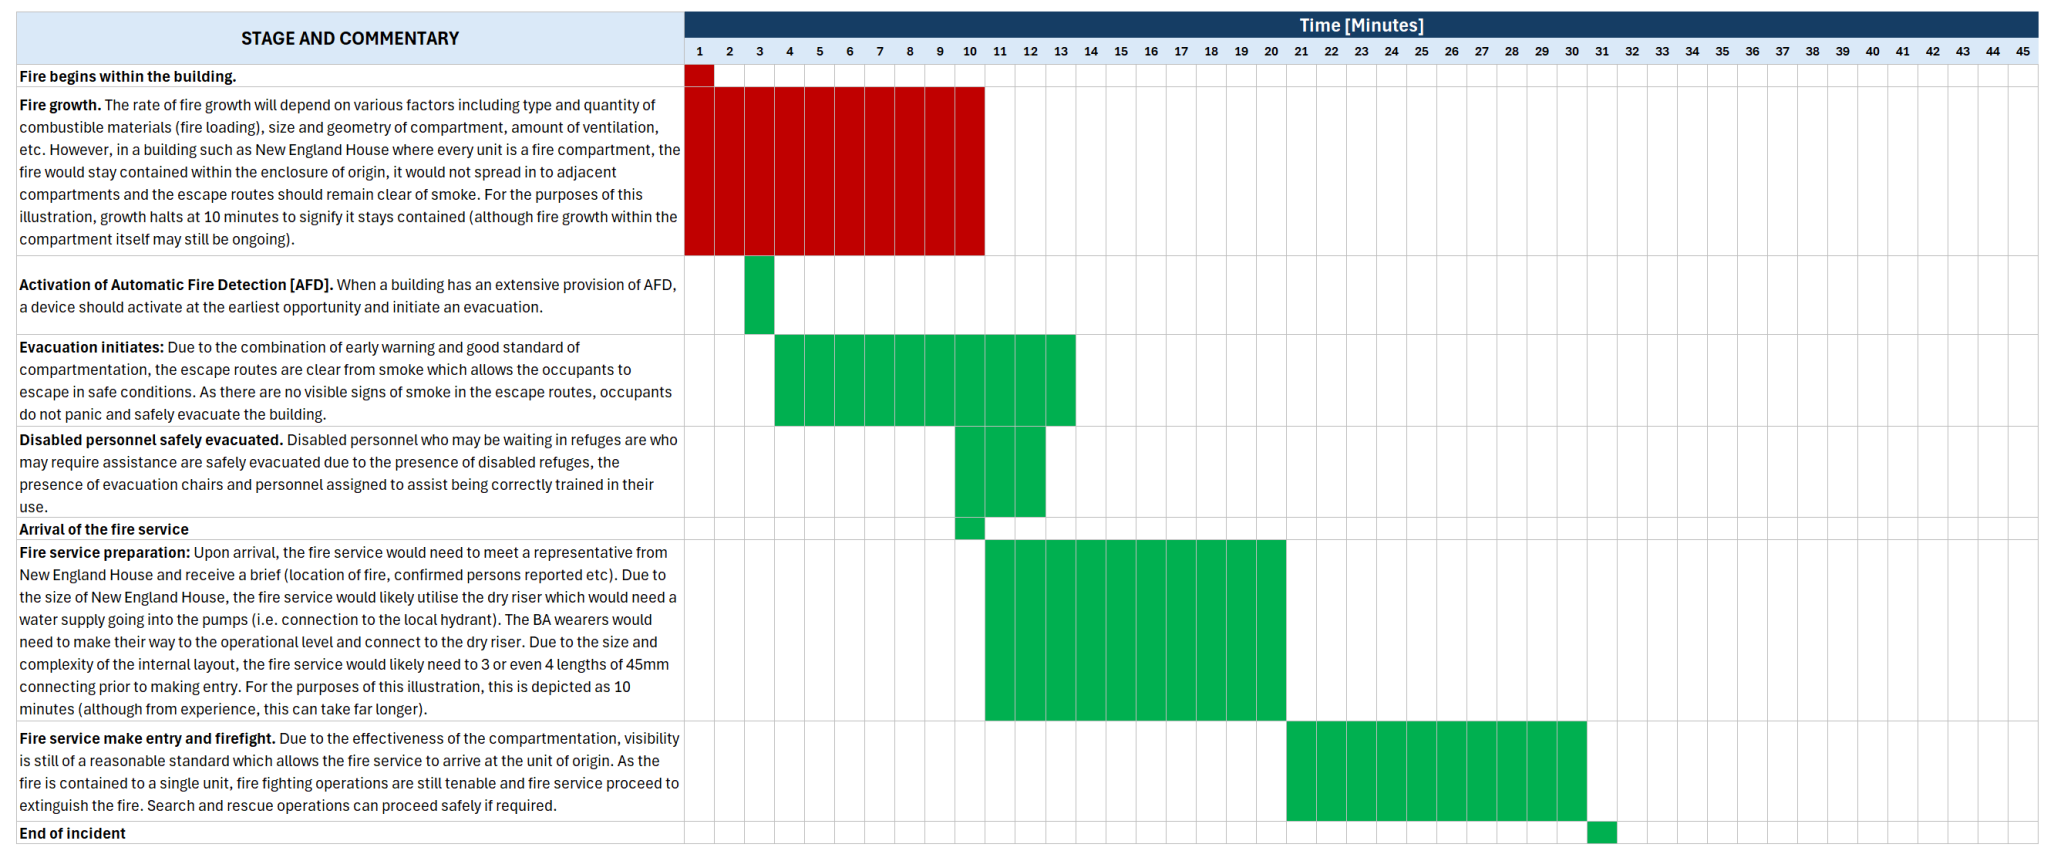
EXAMPLE OF HOW A BUILDING WHICH MEETS CURRENT STANDARDS SHOULD RESPOND IN A FIRE SITUATION:
