Brighton and Hove Madeira Terrace "Lockwood" Regeneration Project

# Brighton Madeira Terraces

Recommendations for Remedial Work to the Terrace Structure

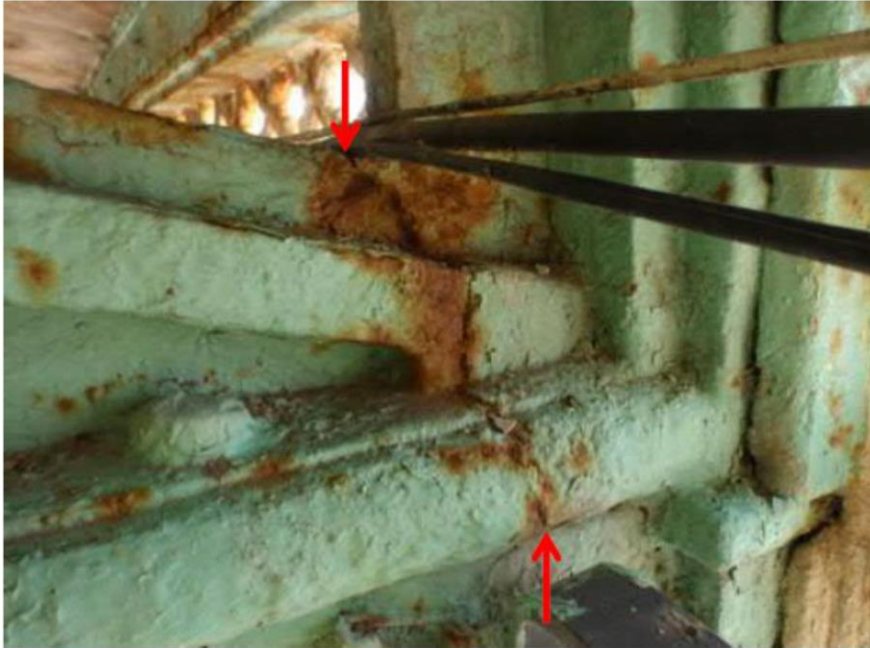
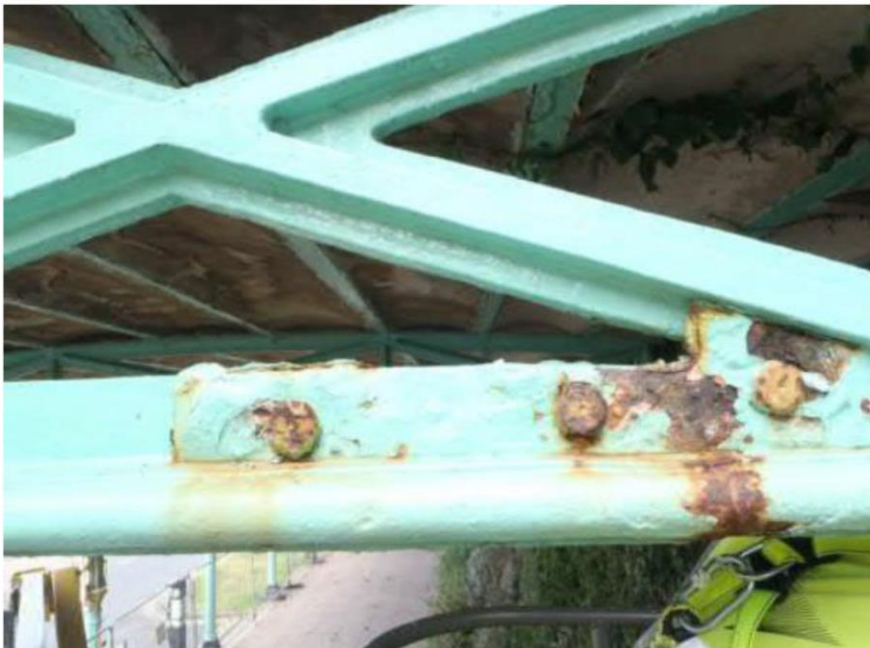
The images below provide some illustration of the weaknesses present throughout the Terraces contributing to their closure.

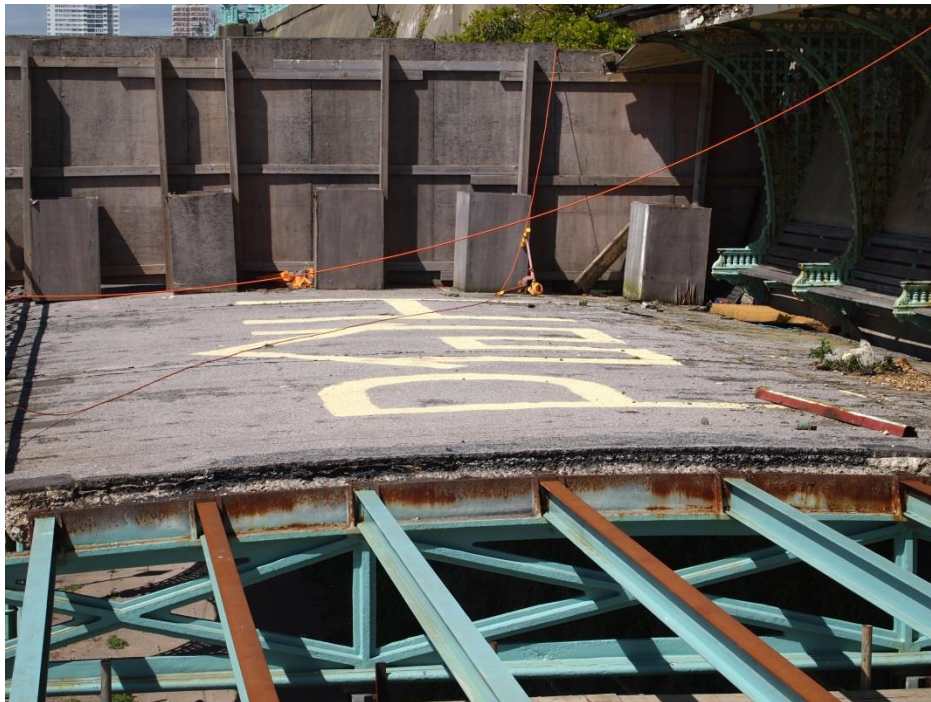
Figure 4.1 – Steel I-beams with concrete jack arches removed

The steel I-beam and concrete jack arch system in its current condition is considered in the Amey reports to be not fit for purpose and proposing a risk of safety in terms of the utilisation of the steel beams in bending. Capacity has been assessed by Amey to be far less than the 5kN/m<sup>2</sup> associated with crowd loading however assumptions of loss of section of the steel beams would have been made as beams are not accessible.

The described deteriorated nature suggests that the unreinforced concrete is carbonated and chlorinated causing spalling and rusting of the steelwork. There is a need to remove the decking from the structure in order to further inspect the supporting elements, replace the steel I-beams and install a new waterproofing system without locking in moisture already contained within the slabs.

As such, it is recommended that the concrete jack arch system should be removed and then both the steel I-beams and concrete arches replaced as new. The considered options for replacement of the decking system include a like-for-like replacement of the steel I-beams and concrete jack arches or a modern replacement option that uses a vaulted precast concrete system, spanning without the need for the steel beams.

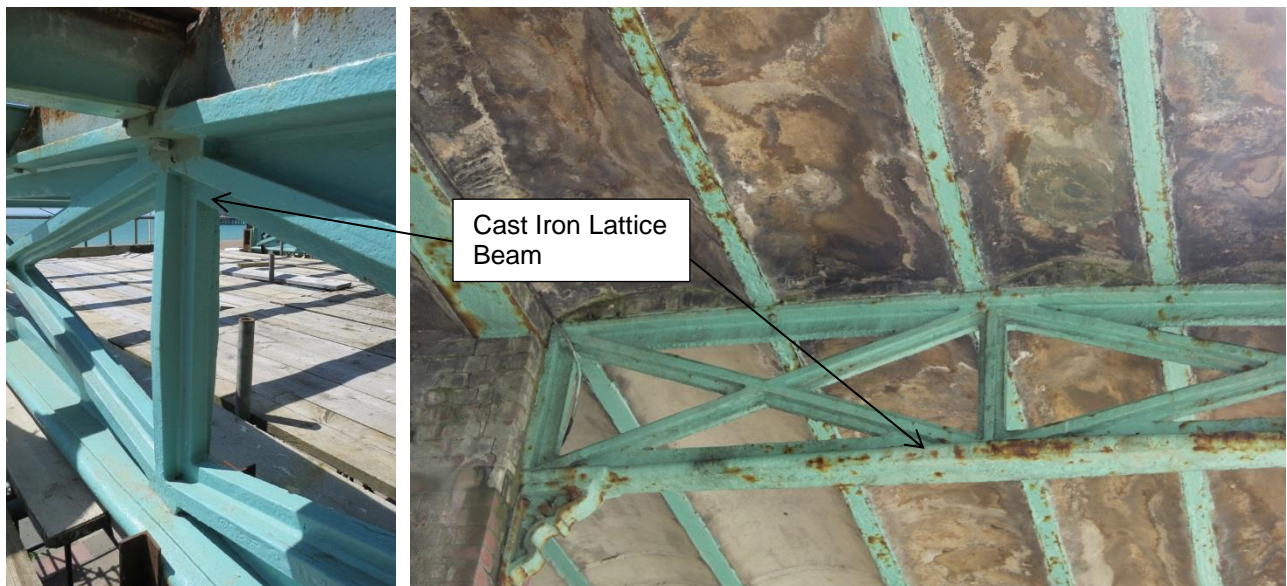
Figure 4.5 – Cast iron lattice beams

The Amey inspection assessments highlight that 3 of the main cast iron lattice beams which were surveyed are known to have fractures that compromise the structural integrity of the members. 1 additional beam has a less severe fracture.

It is anticipated however that latent defects will be uncovered during the works since the inspections were done visually where members are coated in multiple layers of paint and the member is in a stressed state, possibly preventing cracks from opening. An allowance should therefore be made for additional replacements and/or major repair works.

The beams will require grit blast cleaning, repair works, salt washing and painting with a proprietary protective system as described in Section 4.8. The repairs are assumed to be carried out offsite in a controlled environment. This has the benefits of allowing heat control during welding, health and safety control and increased precision. There is however a risk of unlocking stresses during the disassembly that causes cracking.

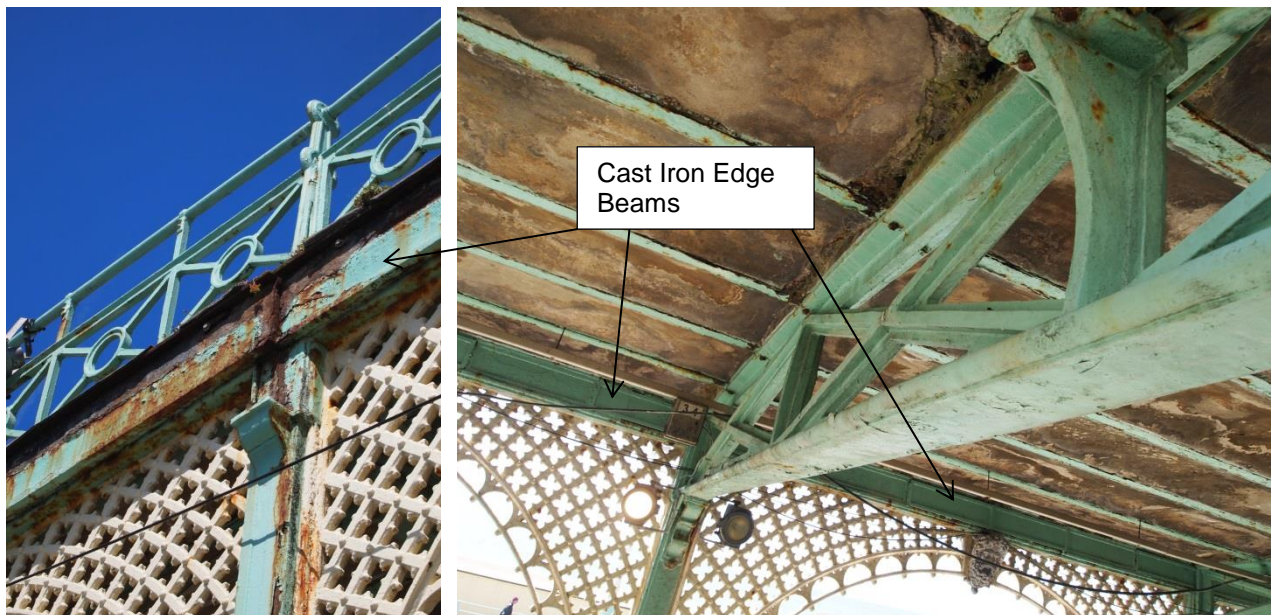
Figure 4.7 – Cast iron edge beam

The Amey inspection reports suggest that the condition of the cast iron edge beams is generally good structurally however various cracks have been highlighted. It is anticipated that these cracks can be repaired using, for example, plate bonding; however a contingency for beam replacements should also be made for any serious defects discovered during the works. The beams are to be disassembled, grit blasted, salt washed, repaired and painted as per the lattice beams. Minor and major latent defects are likely to be found which should be repaired accordingly. Similarly to the lattice beams, the load capacity of the edge beam is unknown.

Bolting of strengthening plates is not recommended due to stress concentrations in the cast iron due to drilled holes and torquing of bolts. Future rust forcing of the mild steel elements is also a risk. Plate bonding using either steel plates or carbon fibre plates is preferred. Plate bonding can be utilised both for shear and tension bending. Metalock cold stitching would be appropriate for repair of shear cracks if appropriately specified.

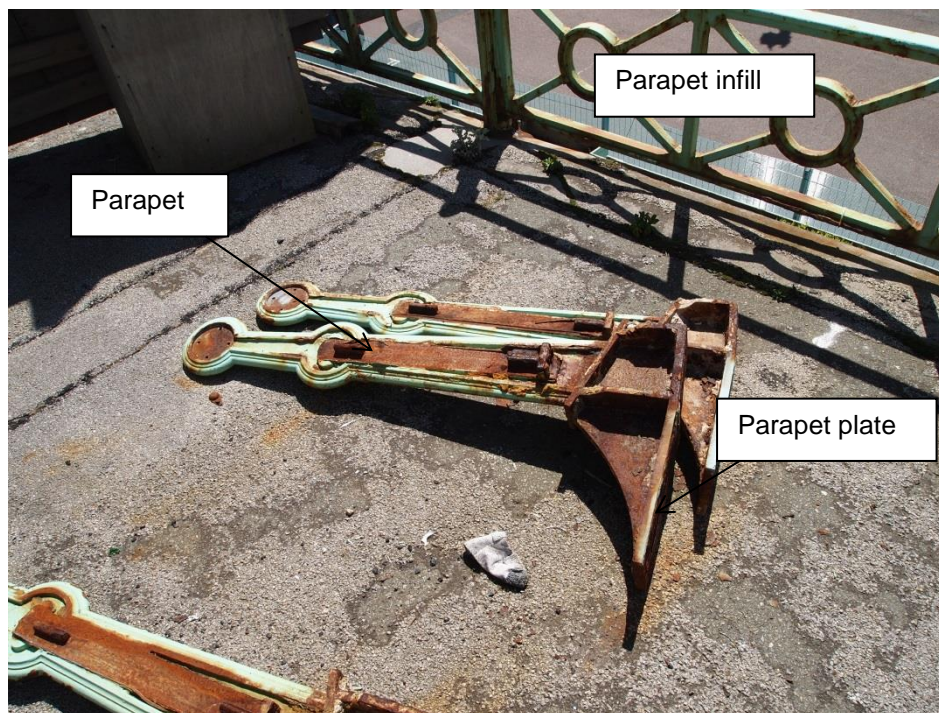
Figure 4.9 – Cast iron parapets, parapet plates and infills

The Amey inspections found that the majority of the parapet base plates are moderately corroded at the surface. There are also a number of known fractures in the plates, at least 1 per bay recorded in approximately 18% of the bays surveyed. It appears that cracking has occurred to the base plate at the final pair of connecting bolts. The bolts appear to be corroding which may have induced cracking due to rust forcing which should be confirmed following closer inspections.

It also appears that the base plate provides a secondary function of splicing the top flanges of the cast iron truss to the top flange of the edge beams which in turn are bolted to the top of the column.

It is worth undertaking a local assessment of this connection as it may perform satisfactorily as is. However at present, no analysis has been performed on the parapet plates and posts and therefore these cracks within the parapet base plates are assumed to compromise the bending capacity of the plates. It is suggested these plates are repaired or replaced.

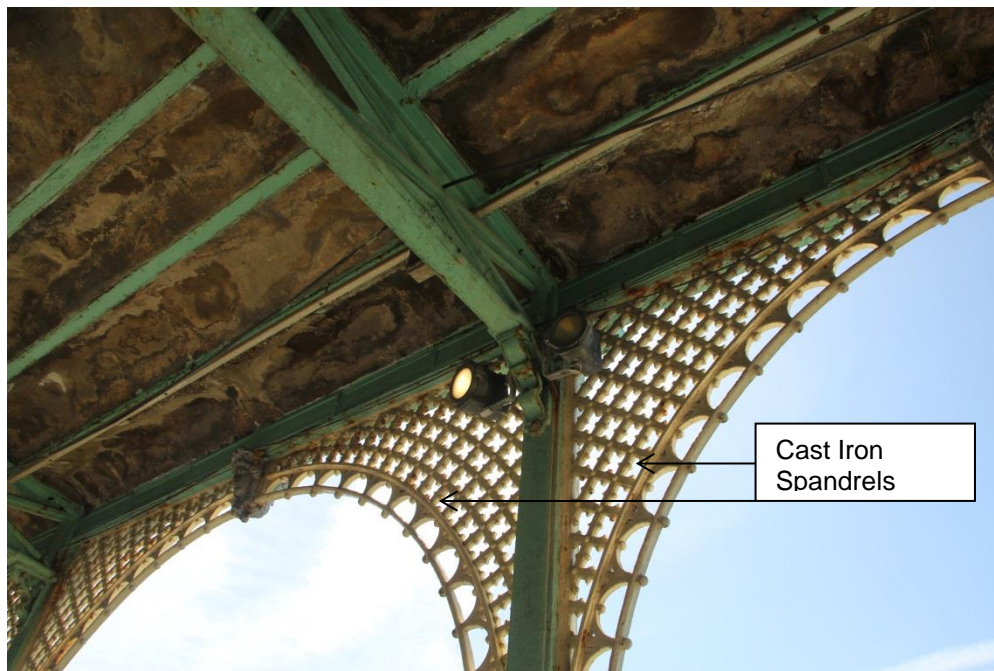
Figure 4.11 – Cast iron spandrels

The current view is that fractures in the spandrels shall be repaired however from previous experience it is possible that on release from its stressed state the spandrel may fracture and/or fall apart. The primary objective of any repairs would be to safeguard against whole sections or small parts of the spandrels falling and causing injury or damage to third parties.

Various options exist to contain, restrain or repair and this might be preferable to wholesale re-casting and replacement.
