Application Number: BH2009/03020 **Ward:** Stanford

Address: The Pantiles, Shirley Drive

Proposal: To fell 1 x Beech (*Fagus sylvatica*) covered by Tree Preservation Order (No 9) 2006

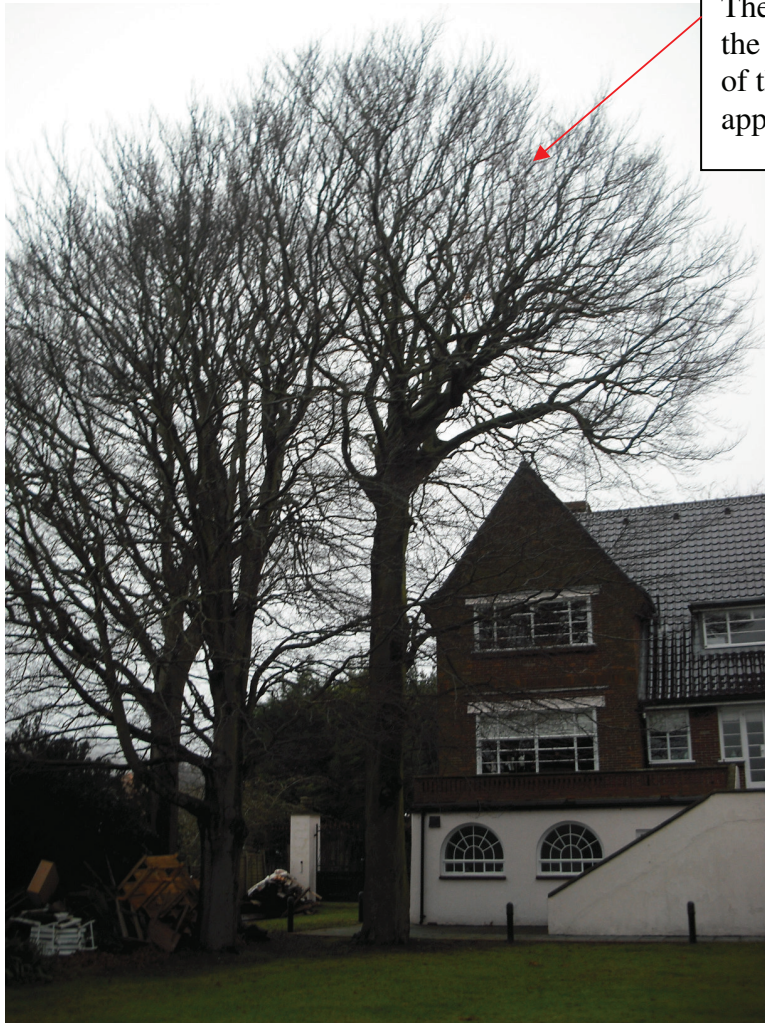
- 4.1 The tree, the subject of this application is mature, and is located approximately 5 m away from the property on the edge of a lawned area. The tree has a lop sided canopy due to suppression by surrounding trees. Foliage size, shape and colour are all indicative of sound vigour. Deadwood <150mm diameter is present throughout the canopy. The canopy is unbalanced to the north largely due to a proliferation of branches from a multiple branch union at 12m. The resultant limbs are weighted significantly over the adjacent property. Visual assessment from ground level using binoculars indicates that the stem-branch unions have bark inclusions suggesting potentially compromised points of attachment.

- 4.2 A further major limb union at 6.5m gives rise to a heavy limb to the south. The main stem is deeply fluted from 0.3 – 0.5 m on the western side and 0.3 – 0.5 m on the northern side.

- 4.3 Reaction wood is evident on buttress roots to the north and west, however, decay detection with a probe and sounding mallet suggests that no decay is present. The formation of the reaction wood is potentially as a result of historical stem / root loss or damage.

The tree
the subject
of this
application.

- 6.1 This is a mature Beech with visible signs of weakness that cannot be ignored. Harsh pruning of the tree to sufficiently reduce the risk of it failing in an uncontrolled manner may lead to the decline of the tree. Even if it does not lead to its decline, such pruning would render the tree unsightly resulting in a loss of visual amenity and therefore potentially render it unworthy of its present status of Preservation Order.
- 6.2 Given the above, it is recommended that permission be given to fell this tree at this time and a replacement secured for future generations.

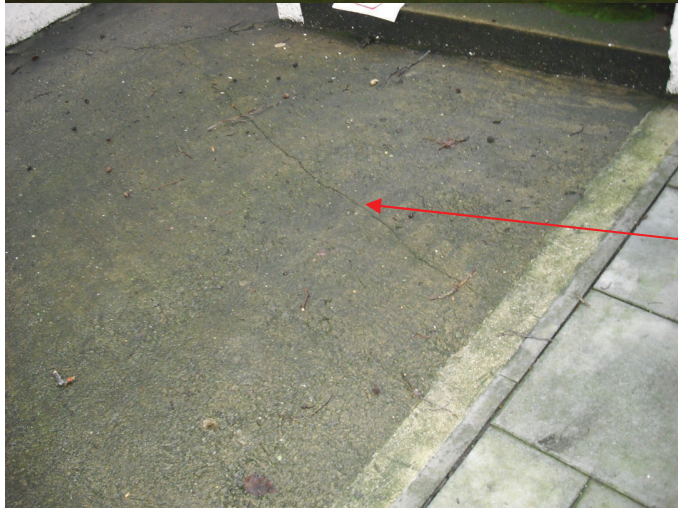
- 5.1 The tree the subject of this application is a mature Beech tree, approximately 16 m in height with an uneven crown spread of 11 – 14 m.
- 5.2 The tree is approximately 5m away from the property itself. Hairline cracking is evident in the paved area between the tree and the house, indicating that root activity may be close to the property.
- 5.3 Weak stem unions in the tree as outlined above need to be addressed. It is usual to prune a tree hard to sufficiently reduce the risk of stems failing, however, Beech trees do not respond well to such pruning and such action could be to their ultimate detriment.
- 5.4 The tree, which has recognised potential points of failure, is close to a property that has a constant stream of visitors. Ignoring the recognised points of potential failure is not an option.

Cracking in
paving
between
house/tree.
