Application Number: BH2010/00887 **Ward:** Woodingdean

Address: 76 Crescent Drive North, Woodingdean

Proposal: To fell 1 x Cupressus macrocarpa (Monterey Cypress) covered by Tree Preservation Order (No 13) 1990. (Area Order).

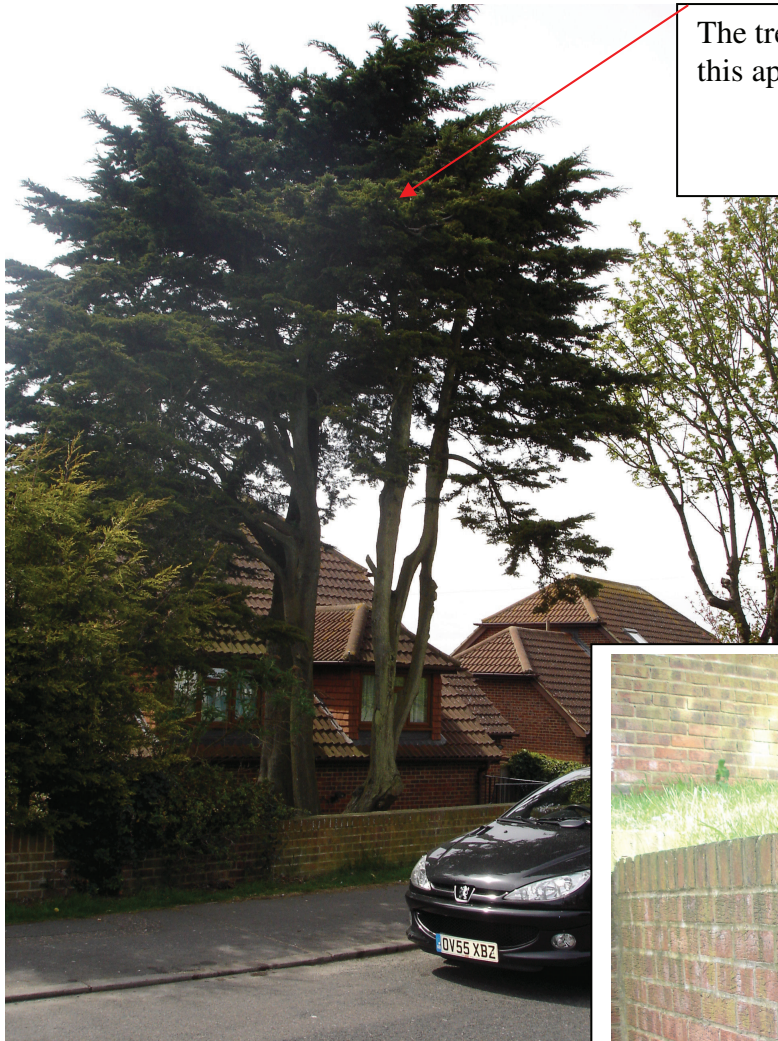
5.1 The tree the subject of this application is approximately 14 – 15 metres high with a crown spread of 8 - 10 metres. It is triple stemmed from approximately 1 metre from ground level with the weight of the tree being mostly over the public highway.

The tree the subject of this application.

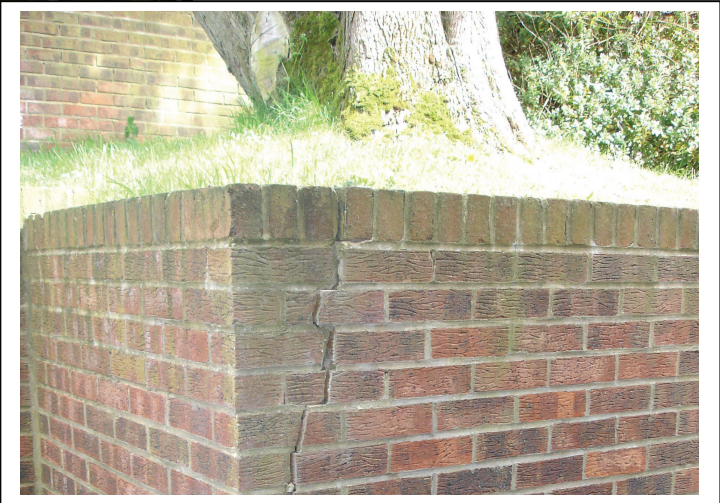
5.5 The tree originally had four main stems and one has been completely removed, possibly at the time the land was developed. This large wound at the base of the tree has been assessed and hollow sound tests indicate there may be pockets of basal decay in this vicinity

Small planter area tree is in. Note large basal wound.

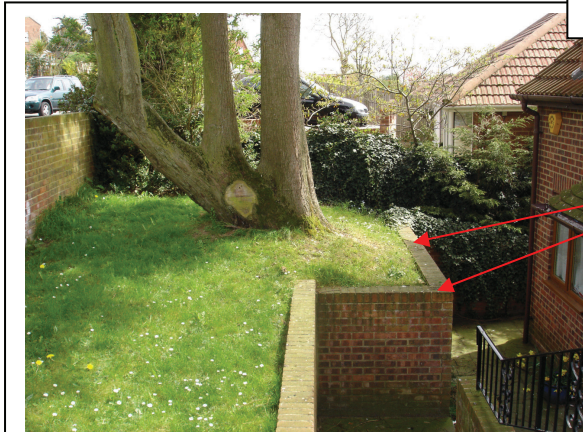
4.1 The applicant wishes to fell this tree as it has caused large cracks in the supporting wall of the planter that holds the tree in place.

Brick planter cracked in two locations, cracks likely to have been caused by roots of tree.

7.2 The retaining wall could be fixed and the tree remain in situ, however, it is the opinion of the inspecting officer that the lack of structural roots on the south side of this large specimen tree could seriously affect its structural stability.
