Application Number: BH2010/00887 **Ward:** Woodingdean

Address: 76 Crescent Drive North, Woodingdean

Proposal: To fell 1 x Cupressus macrocarpa (Monterey Cypress) covered by Tree Preservation Order (No 13) 1990. (Area Order).

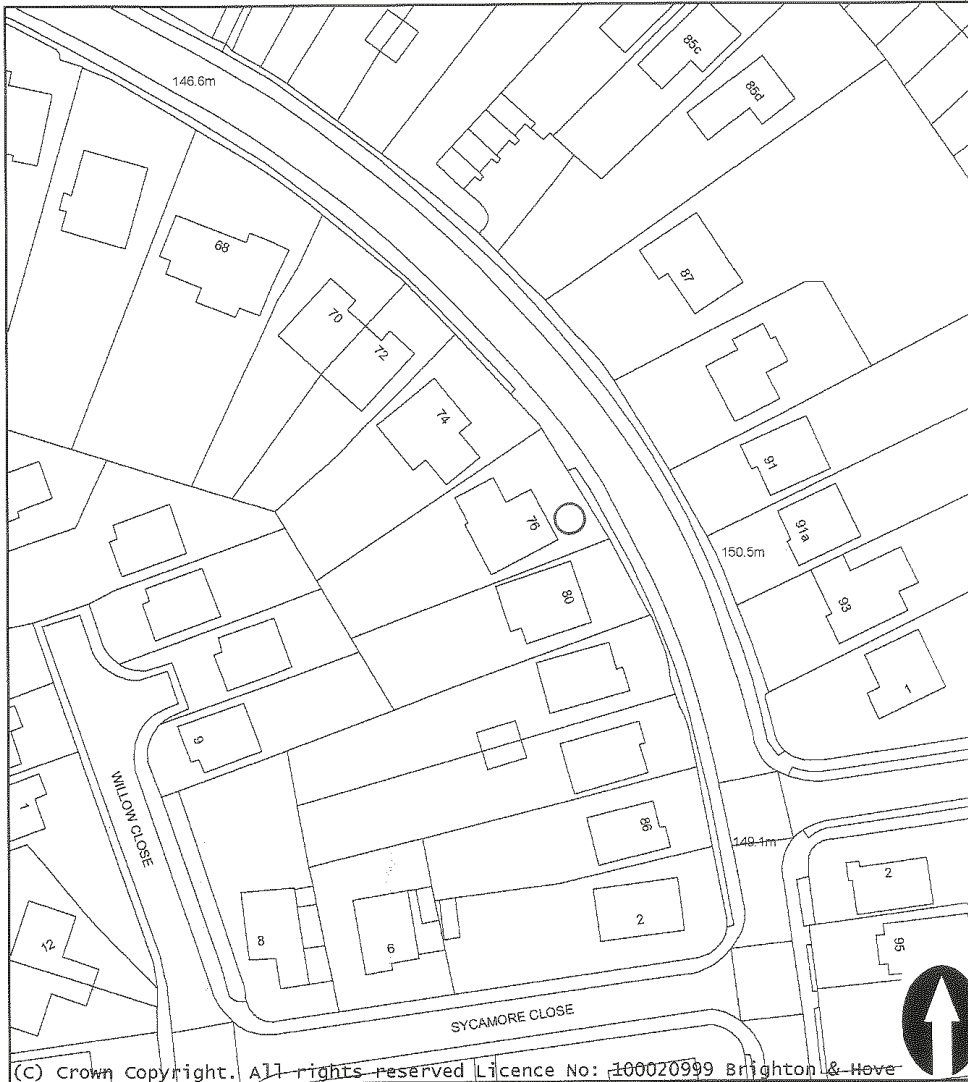
4.1 The applicant wishes to fell this tree as it has caused large cracks in the supporting wall of the planter that holds the tree in place.

5.5 The tree originally had four main stems and one has been completely removed, possibly at the time the land was developed. This large wound at the base of the tree has been assessed and hollow sound tests indicate there may be pockets of basal decay in this vicinity

Brick planter cracked in two locations, cracks likely to have been caused by roots of tree.
